BOTTLED WATER COMPANY IMPLEMENTS LARGE-FORMAT IR WINDOWS

The company brought in consultants for recommendations on placement, sizing, and types of infrared windows to be installed at the Ontario, Canada facility. After an initial site survey, the consultants recommended the IRW-xPC series in various sizes to complete this project. The IRW-xPC series is a NEMA 4 / IP65 rated IR window and ideal for indoor applications. Available sizes are 6, 12, and 24 inches.

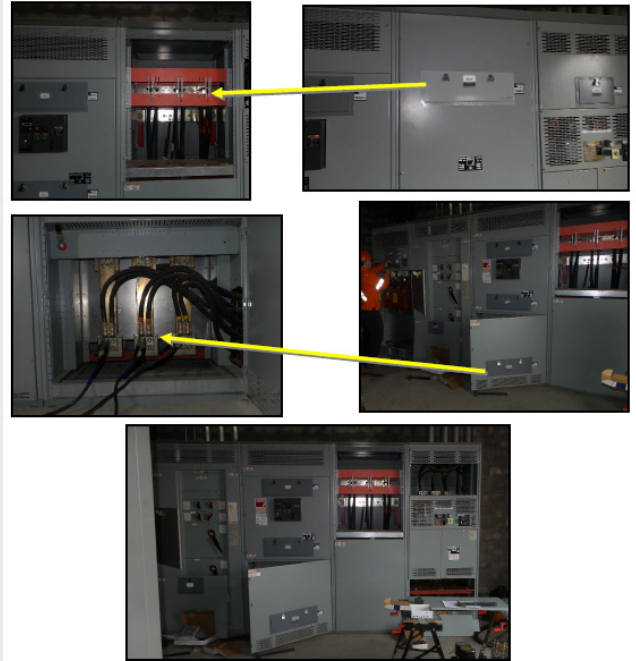
The bottled company installed 24-inch large-format IR windows in main breaker buss cabinets

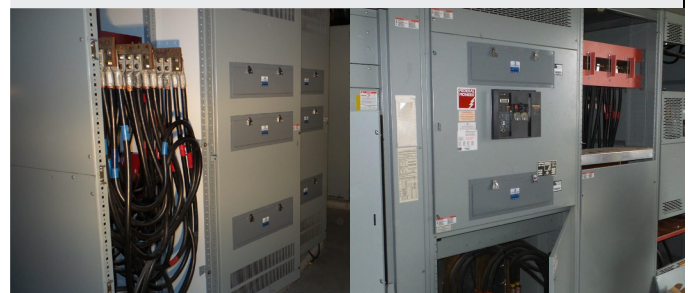
Installation Requirements:
Incoming line connections
Main Breaker

Incoming line connection and main breaker cabinets were also fitted with 24-inch windows
